Pride Home Inspections, LLC.

Whole House Inspection

123 My St

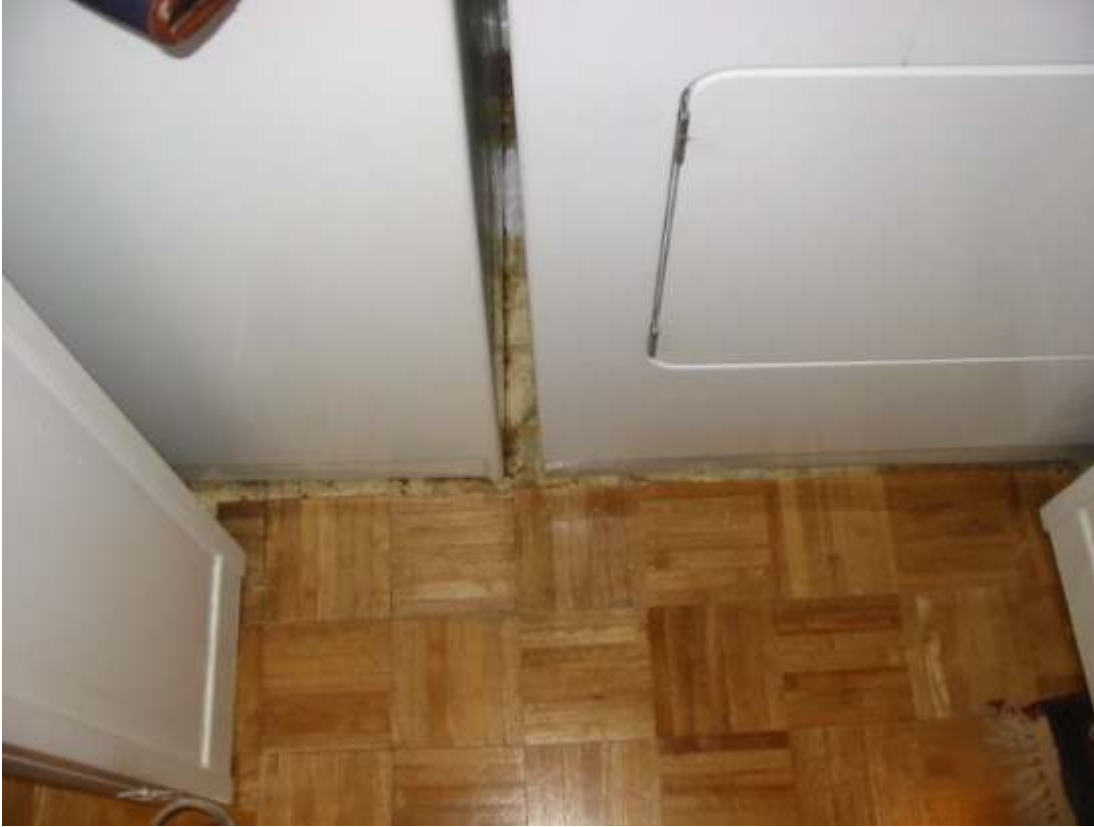
At the time of inspection, Parkay floor ends in the laundry room. There were no divider found between the floor in laundry room and the parkay flooring. Recommend a divider be installed between the floors.

Rating - COMMENT

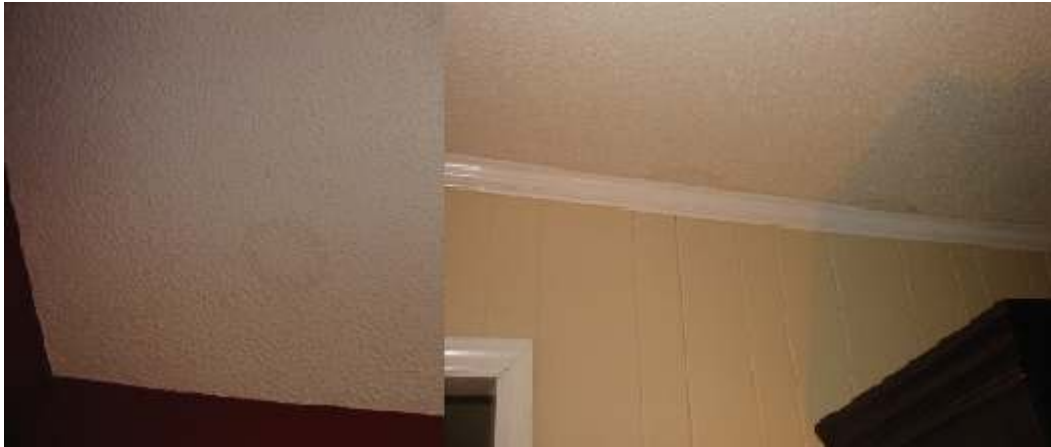
At the time of inspection, There were some stains found on the ceiling. Appears to be an old leak. Recommend having a licensed contractor evaluate and repair as necessary.

Rating - EVALUATE/REPAIR

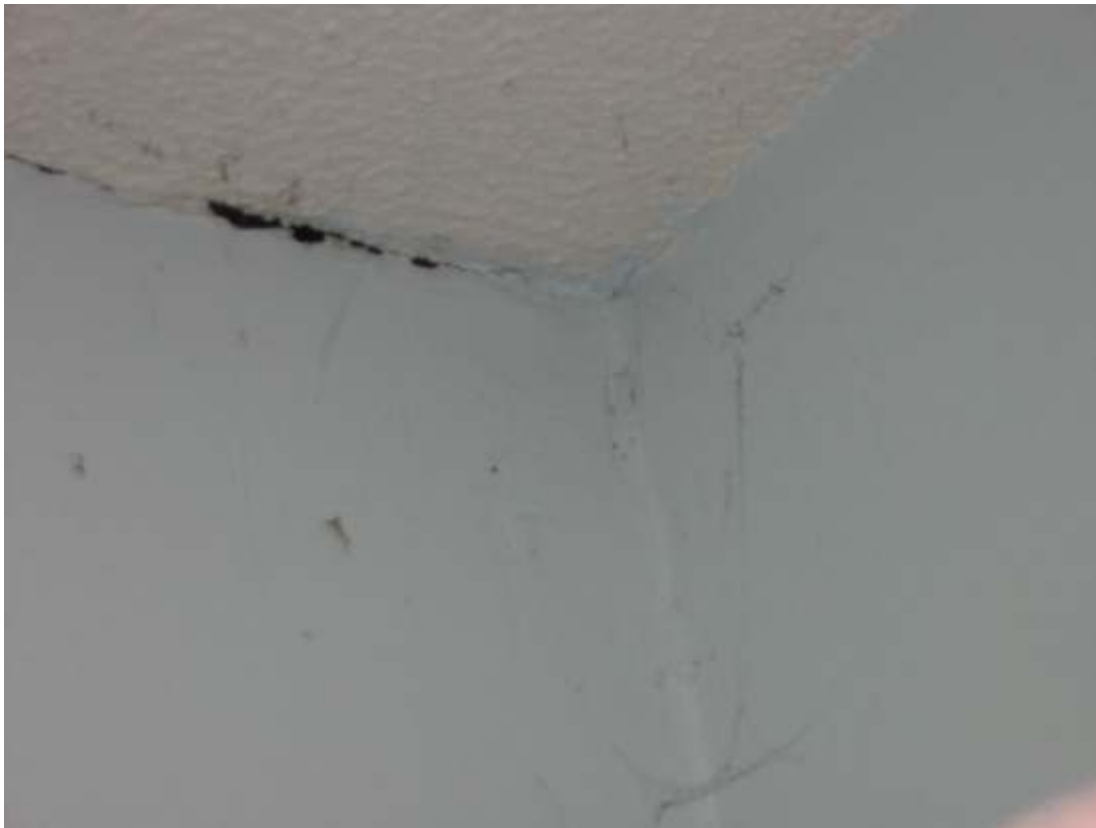
At the time of inspection, A hole in the master closet was found where daylight could be seen. Recommend a licensed contractor evaluate and repair as necessary.

Rating - EVALUATE/REPAIR

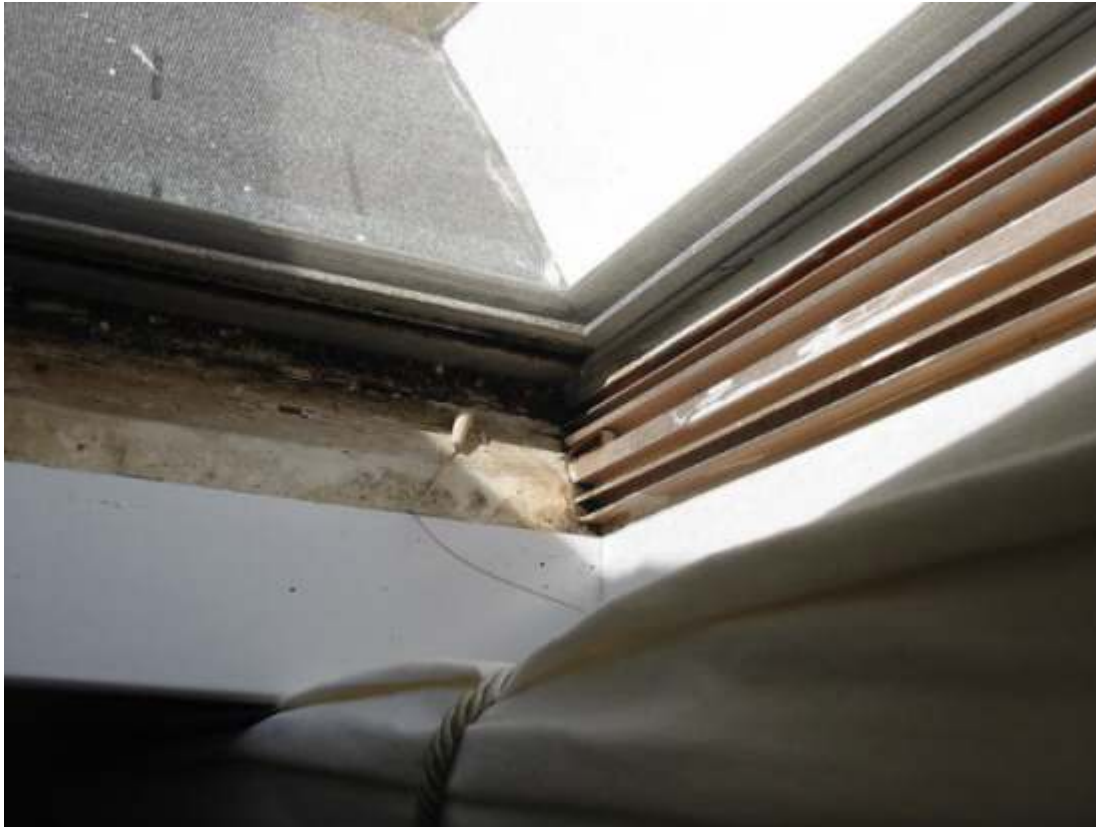
At the time of inspection, There appears to be signs of moderate rot on some of the exterior of the windows. Recommend having a licensed contractor evaluate and repair as necessary.

Rating - MINOR DEFECT

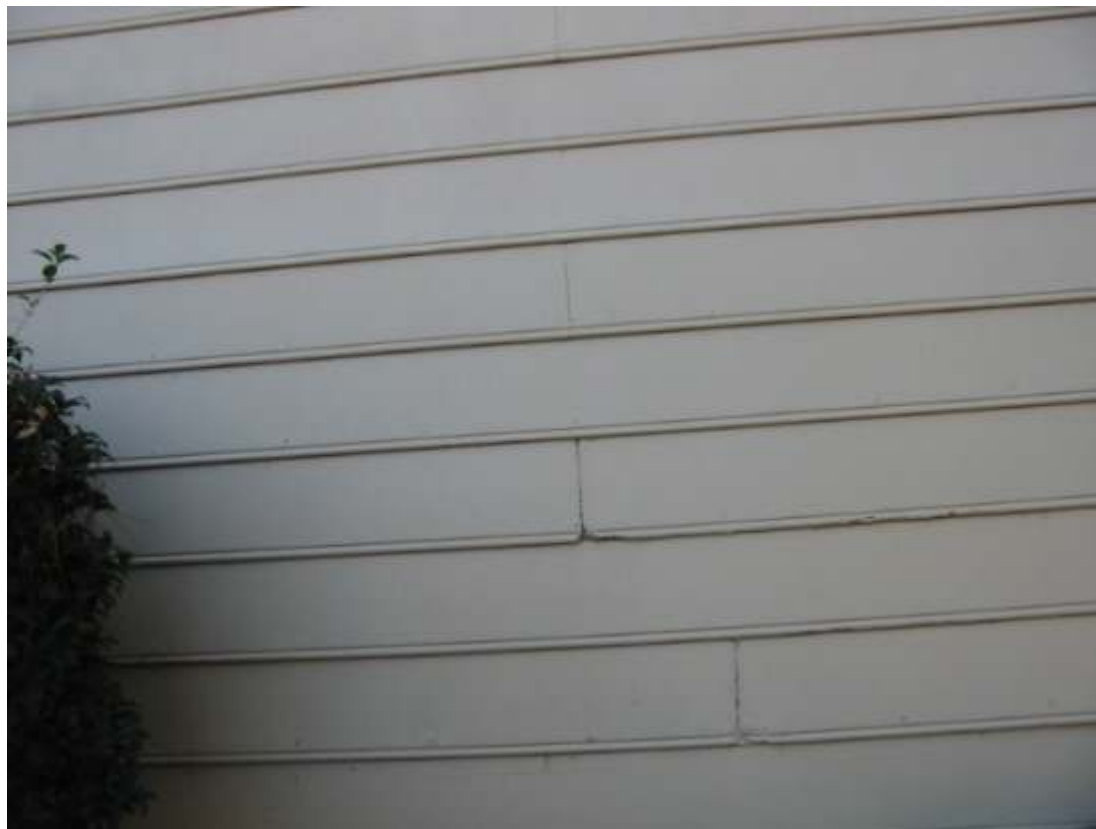
At the time of inspection, Siding is showing signs of rot. Recommend contacting a licensed contractor to evaluate and repair as necessary.

Rating - EVALUATE/REPAIR

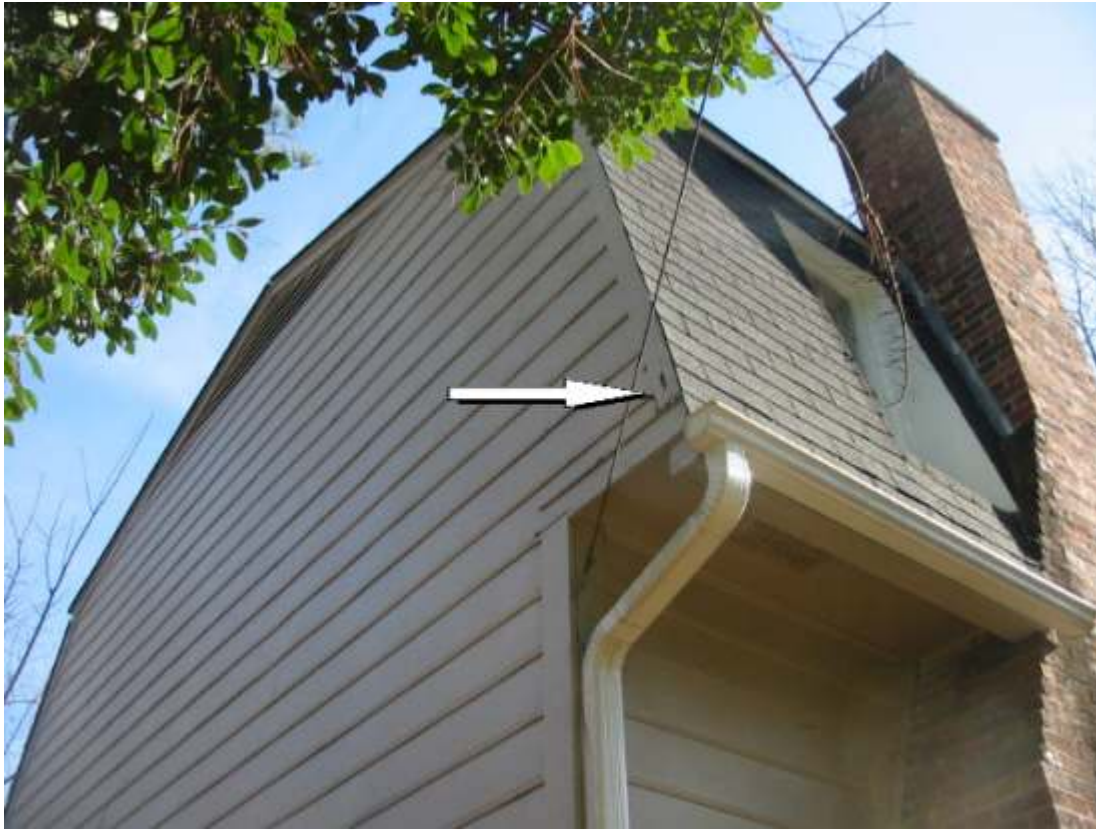
Exterior Trim - Minor Rot

At the time of inspection, There were signs of rot on the exterior trim (soffit and fascia). Recommend having a licensed contractor evaluate and repair as necessary

Rating - EVALUATE/REPAIR
