**Pride Home Inspections, LLC.**

**Prepared Exclusively For - Jane Q Public**

*117 Sample Dr*

**Date - 07/30/2013**

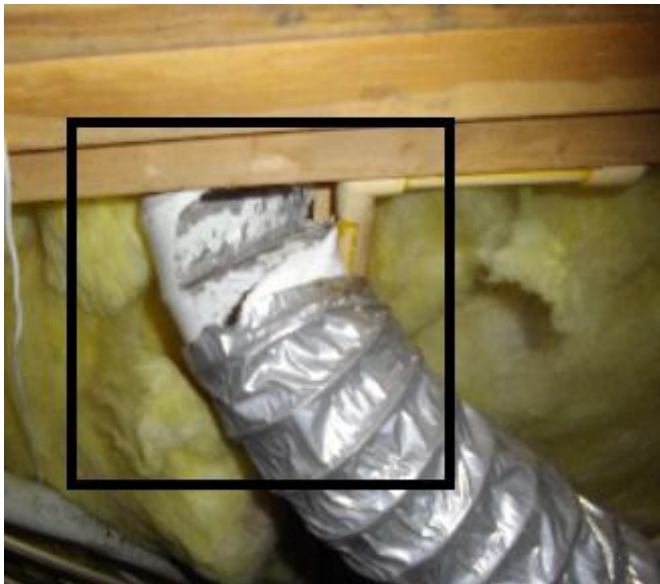
Dryer vent exhaust hose is damaged or missing.

**Recommend having a licensed qualified contractor install a new dryer vent exhaust hose and reconnect the dryer vent to it to prevent moisture and lint from the clothes dryer from blowing into the crawlspace possibly creating a mold issue.**

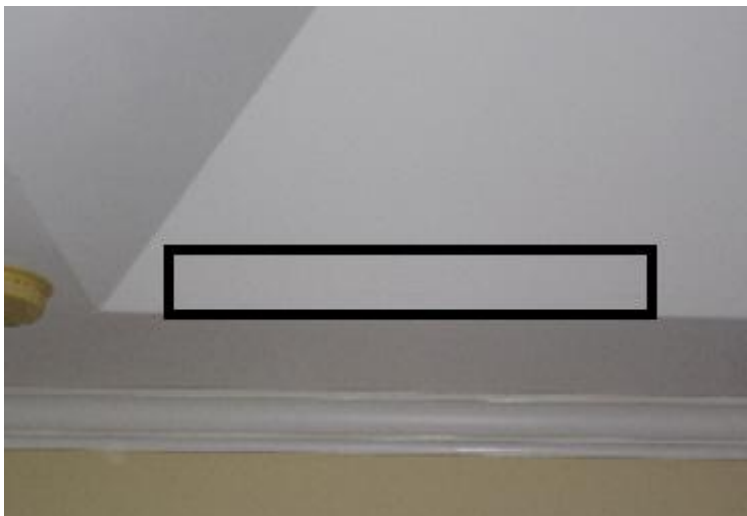
Minor cracks were found in ceilings in one or more areas. They do not appear to be a structural concern, but the client(s) may wish to repair these for aesthetic reasons.
