Pride Home Inspections, LLC.

Prepared Exclusively For - *Johnnie Public*

115 Springs Dr

Date - 07/25/2013

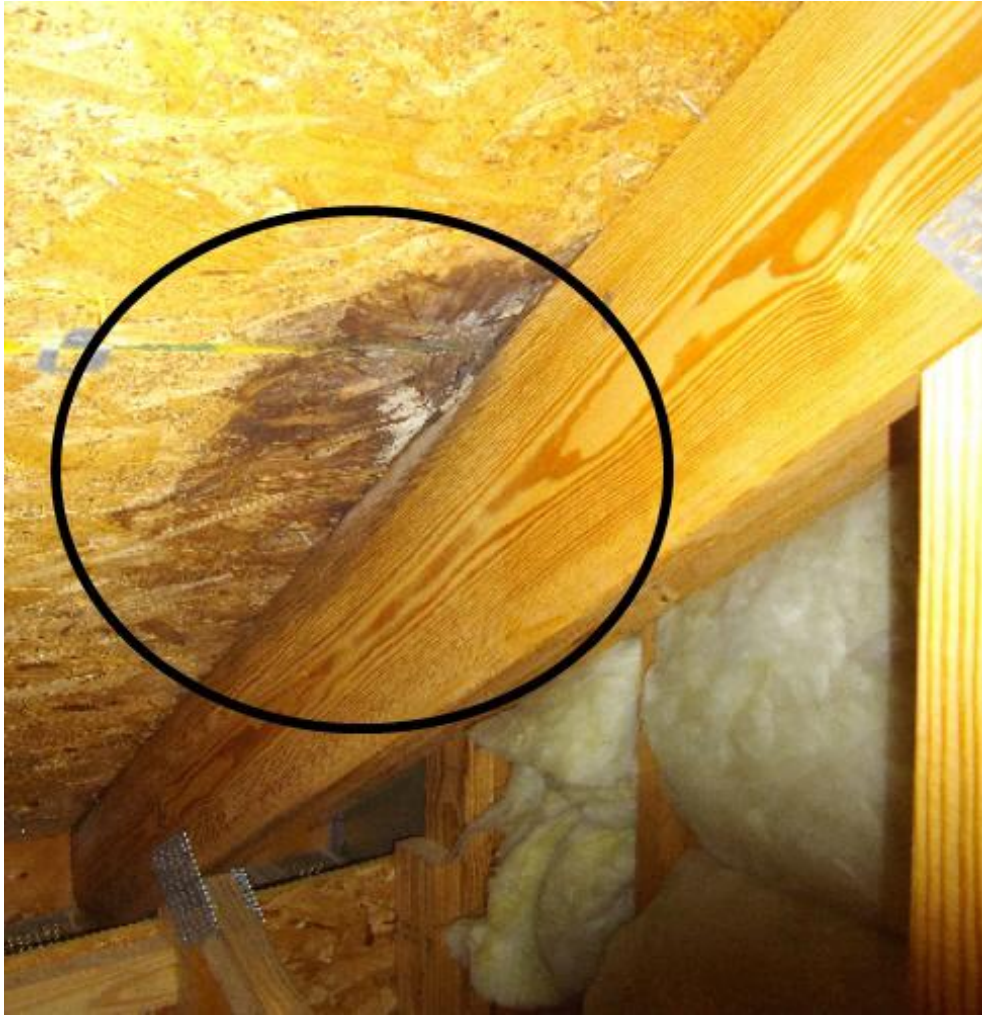
Dark stains were visible on the roof structure in one or more areas. These areas were dry at the time of the inspection, but the OSB board was black and crumbling to the touch. The stains may be caused by a past or active leak.

Rating - MAJOR DEFECT

Recommend having a licensed qualified contractor evaluate and repair as necessary.

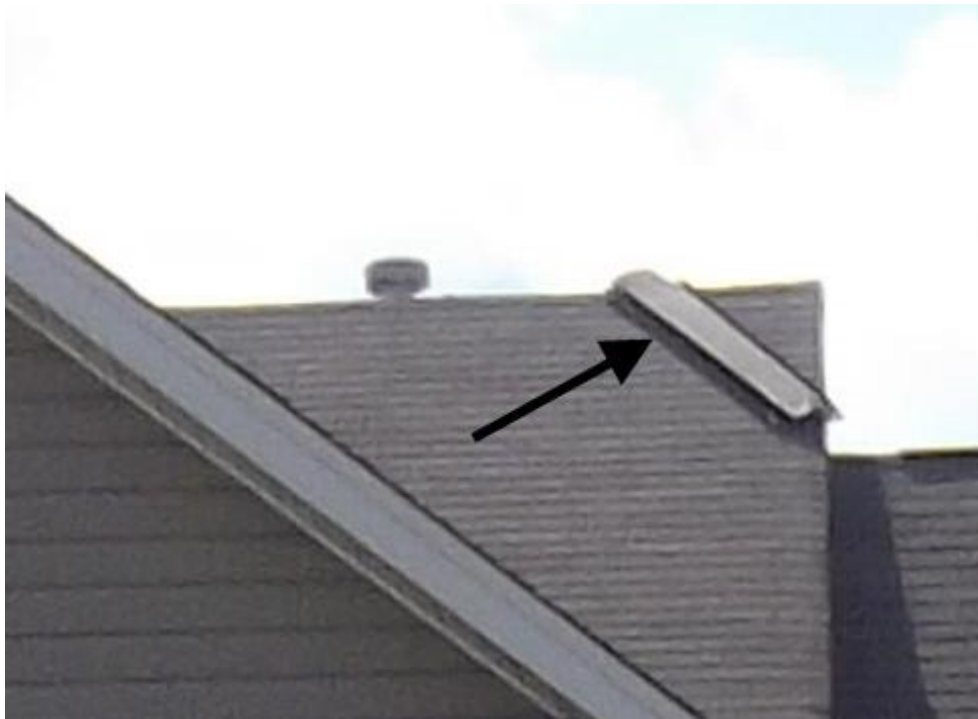
Ridge vent was damaged and/or missing from the main section of the room. It is allowing rain water to come into the Attic space.

Rating - EVALUATE/REPAIR

Recommend having a licensed contractor evaluate and repair as necessary.
