Pride Home Inspections, LLC.

Prepared Exclusively For - Jackie Public

3 Caliway Ct

Date - 06/13/2013

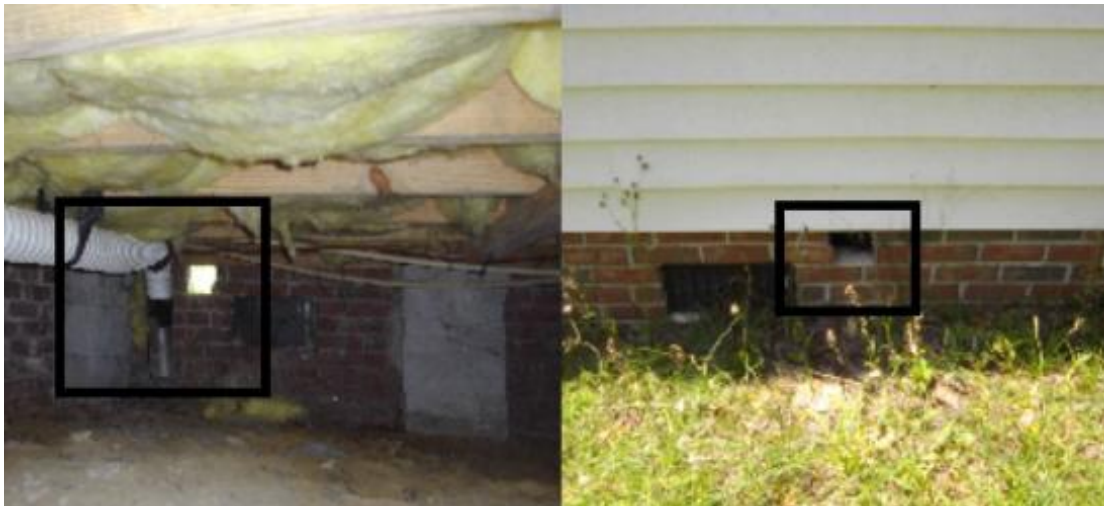
Outside dryer vent is missing.

Recommend having a licensed contractor install a new dryer vent and reconnect the vent hose to it to prevent moisture from the clothes dryer from blowing into the crawlspace.

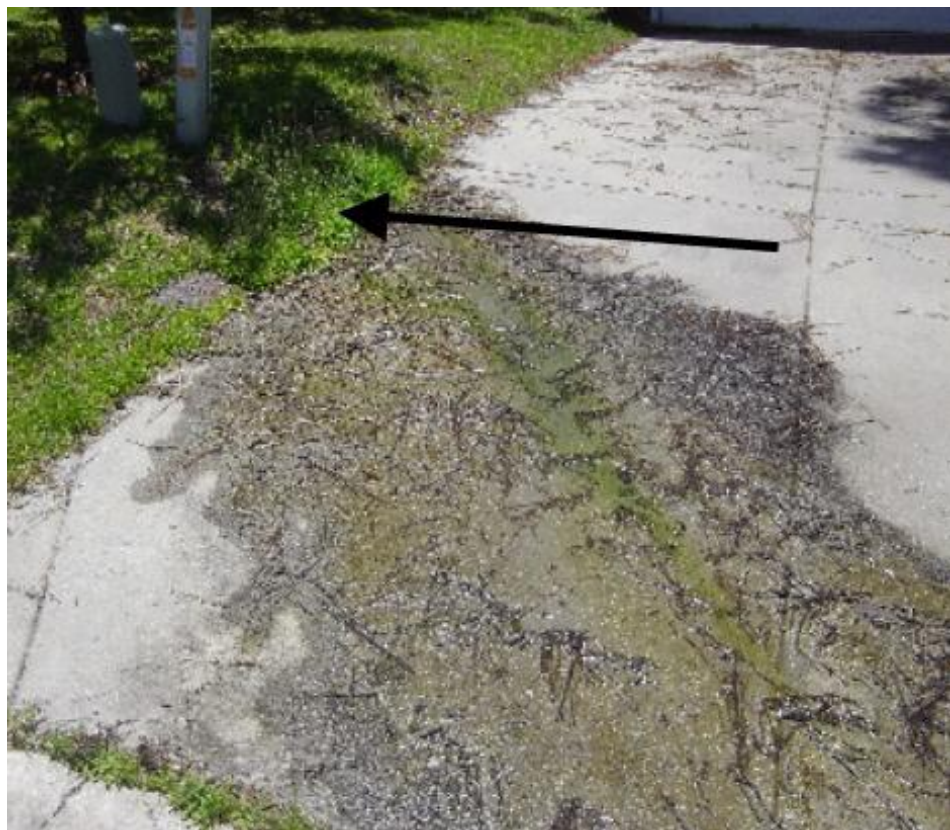
There are visible signs that there is an active leak from the water meter to the shut off. Water was found running across the driveway and/or very wet soil and has not rained recently.

Recommend having a licensed qualified plumber evaluate and repair as necessary.

7/24/13 reinstpection revealed that the water supply line from the meter to the house had been replaced and there was no longer an active leak

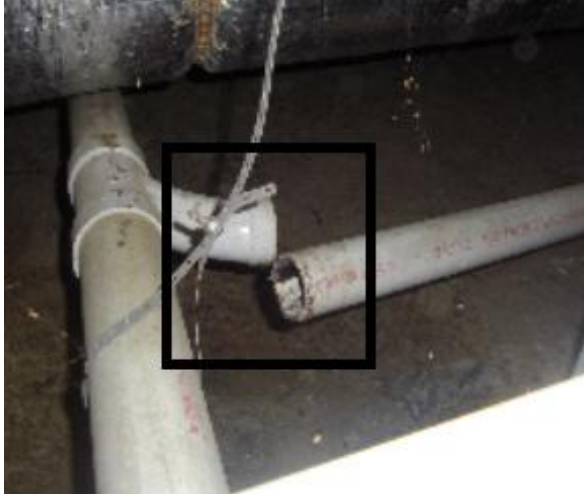
An active leaks was found in one of the drains and/or waste pipes or fittings. The pipe was disconnected.

Recommend having a qualified licensed plumber evaluate and repair as necessary.

7/24/13 reinspection revealed that the waste pipes were reconnect and did not have an active leak.

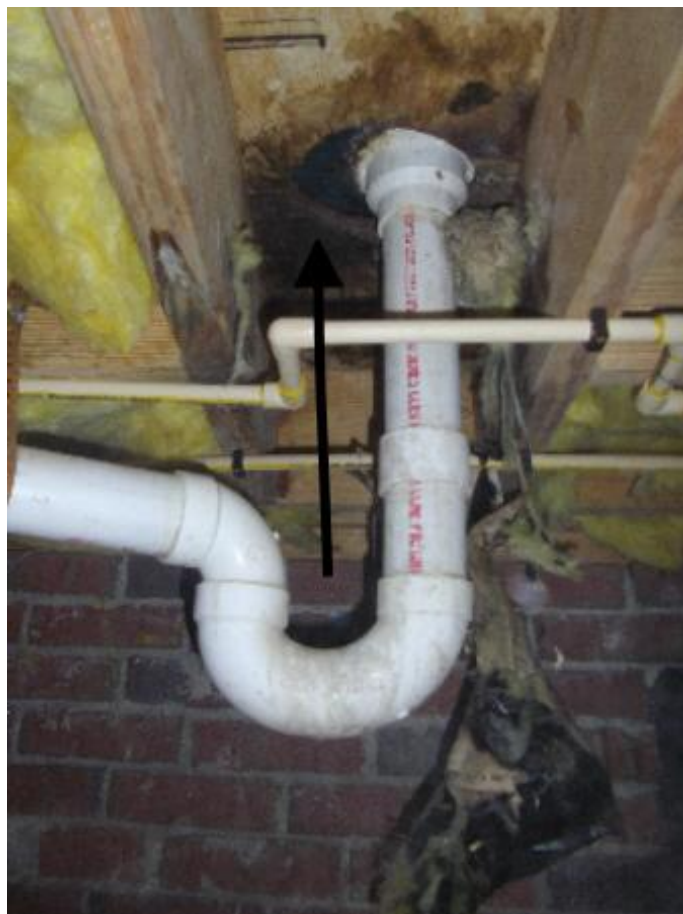
Stains and discoloration of the wood was found in one or more areas in the crawl space. This may indicate that there was a previous leak under the master bathroom (possible under the tub or shower)

Recommend monitoring these areas in the future, and if leaks are found, have a qualified licensed plumber evaluate and repair as necessary. Alternatively, the client(s) may wish to have a qualified licensed plumber evaluate now and repair if necessary.

7/24/13 reinspection revealed the same stains. Contractor may have tested and found no active leaks. Recommend speaking to the realtor or contractor to see what was done.

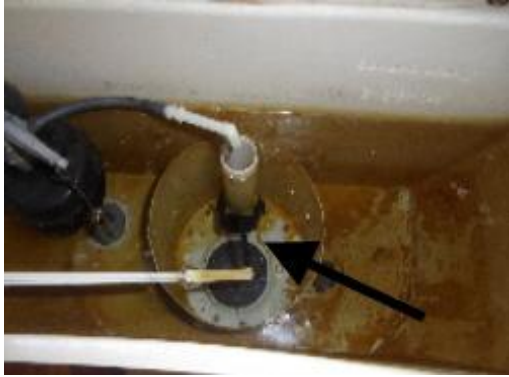
The "flapper valve" in one or more toilets is broken. The toilet will not flush because of this issue.

Recommend replacing toilet components as necessary.

7/24/13 reinspection revealed that the flapper valve had been replaced and was working properly at the time of reinspection.

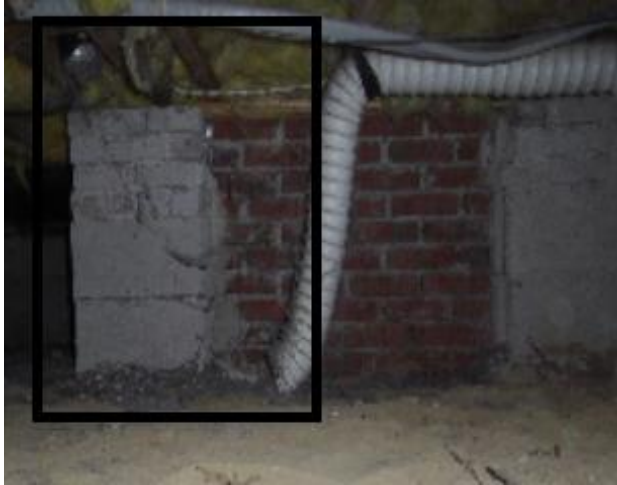
Dryer hose is not connect to the inside dryer outlet in the crawlspace.

Recommend reconnecting the dryer hose line to the outlet to prevent moisture from going directly in to the crawlspace.

7/24/13 reinspection revealed that the dryer hose was refitted with a new dryer hose and outlet

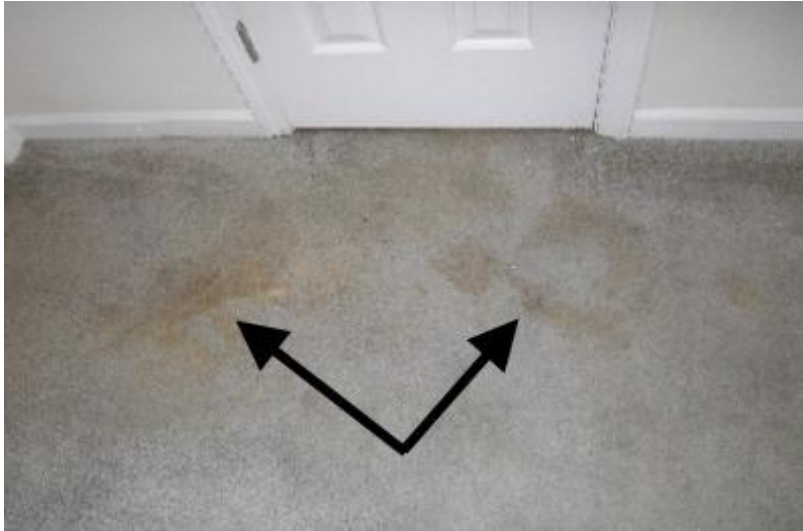
Carpeting in one or more rooms is soiled and/or stained.

Recommend having carpeting professionally cleaned as necessary.

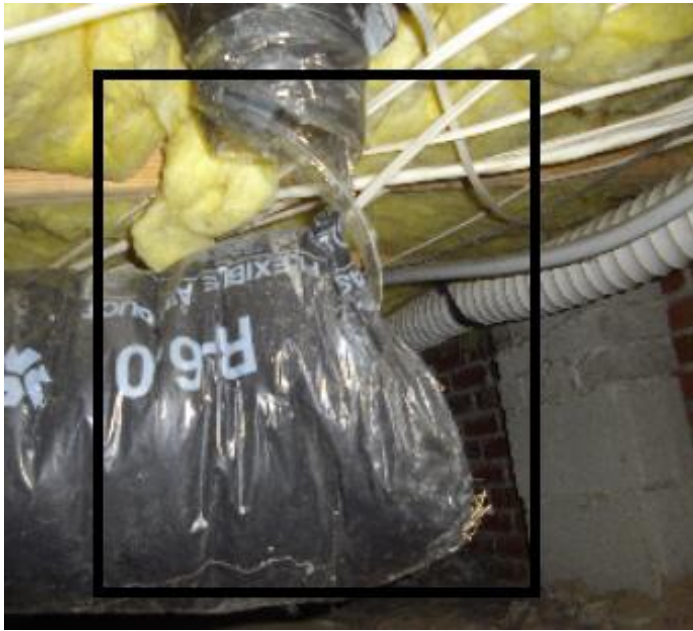
One or more air supply registers has a weak air flow, or no apparent flow, and may result in an inadequate air supply for heating/cooling. The air register in the laundry room is not blowing any air. Upon further investigation, the heating and air duct was damaged/broken as seen in the picture below.

Recommend having a qualified licensed heating/cooling contractor evaluate and repair or make modifications as necessary.

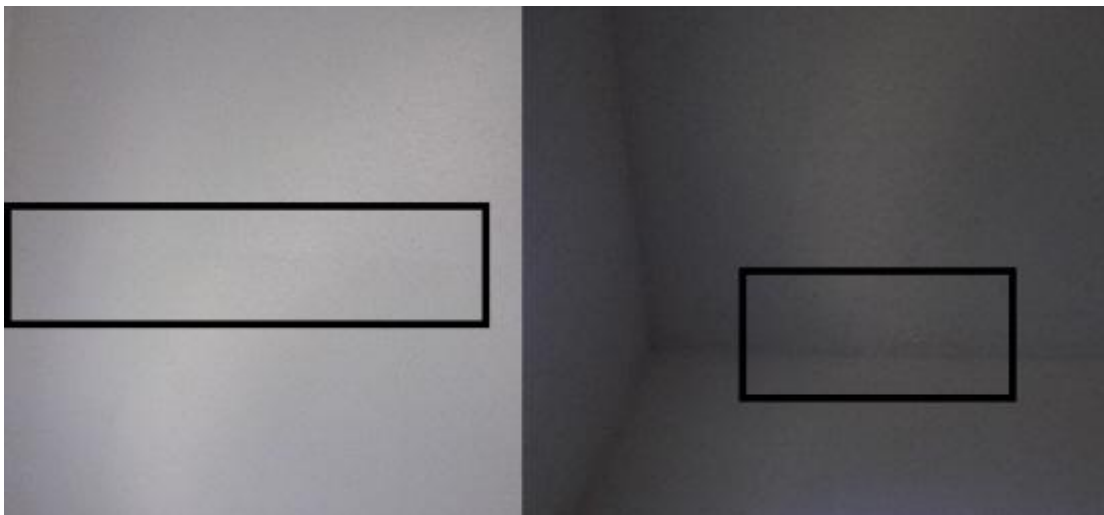
Stains were found in one or more ceiling areas. However, no elevated levels of moisture were found. The stain(s) may be due to past roof and/or plumbing leaks.

Recommend asking the property owner(s) about this, and monitoring the stained area(s) in the future, especially after heavy or prolonged rain. If elevated moisture is found in the future, a licensed contractor should evaluate and repair as necessary.

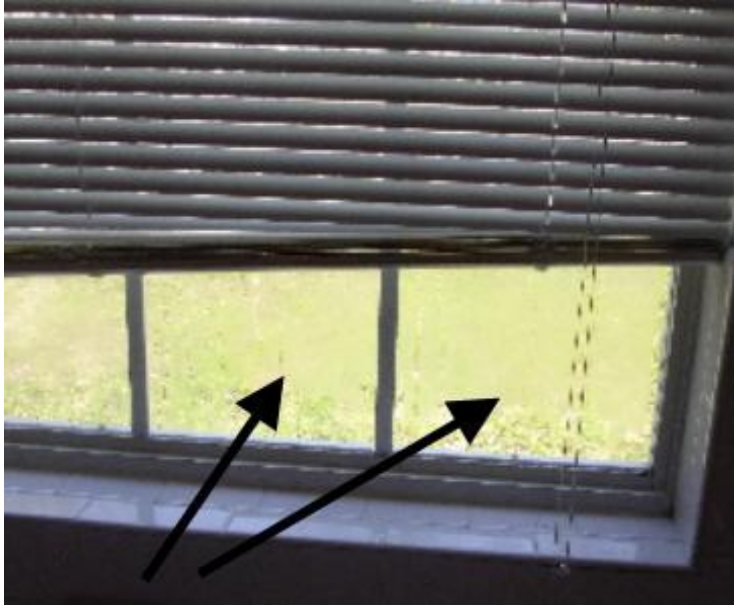
Seals between double-pane glass in one or more windows appear to have failed based on condensation or stains between the panes of glass.

Recommend having a licensed contractor evaluate and repair/ replace as necessary. The client(s) should be aware that evidence of broken seals may be more or less visible from one day to the next depending on the temperature, humidity, sunlight, etc. Windows or glass doors other than those that the inspector identified may also have failed seals and need glass replaced too.

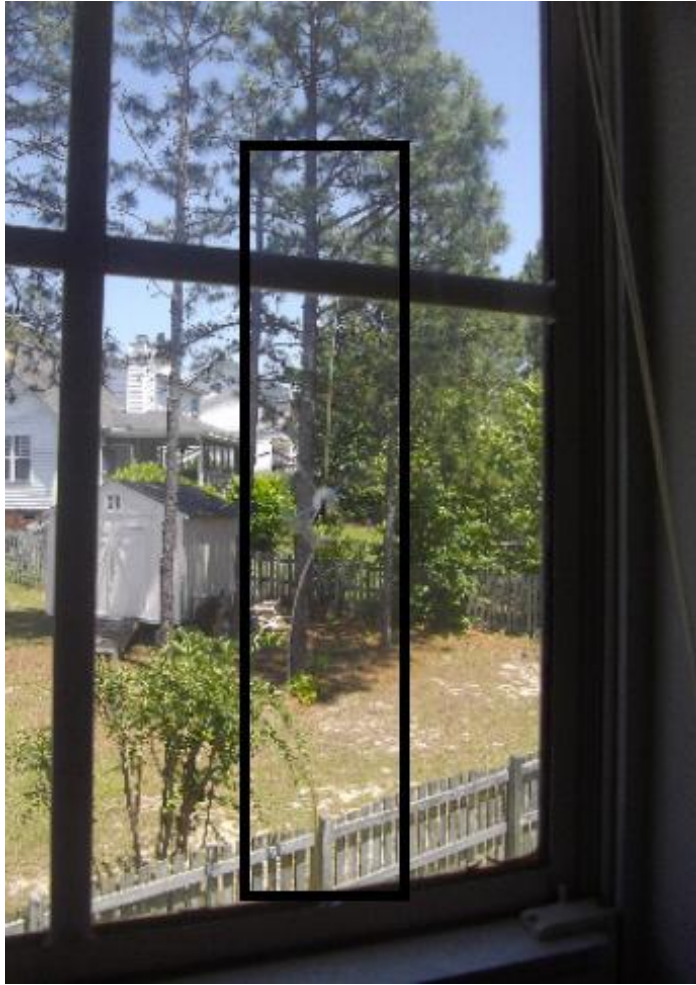
Window glass in one or more windows is cracked/broken. The Front left upstairs bedroom looks like was shot with a pellet.

Recommend having a licensed contractor evaluate and repair/ replace window as necessary.

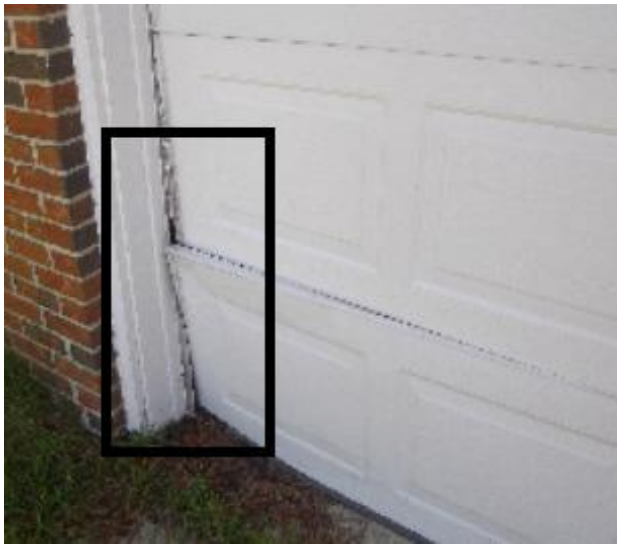
The garage door is damaged or deteriorated.

Recommend and having a qualified licensed contractor replair and/or replace garage door.

7/24/13 reinspection revealed that garage door had been replaced
